New York State Department of Transportation

Yellow Flag NB22CTW016

BIN: 1065318

Location: Span 227, Girder G21 at Pier 226.

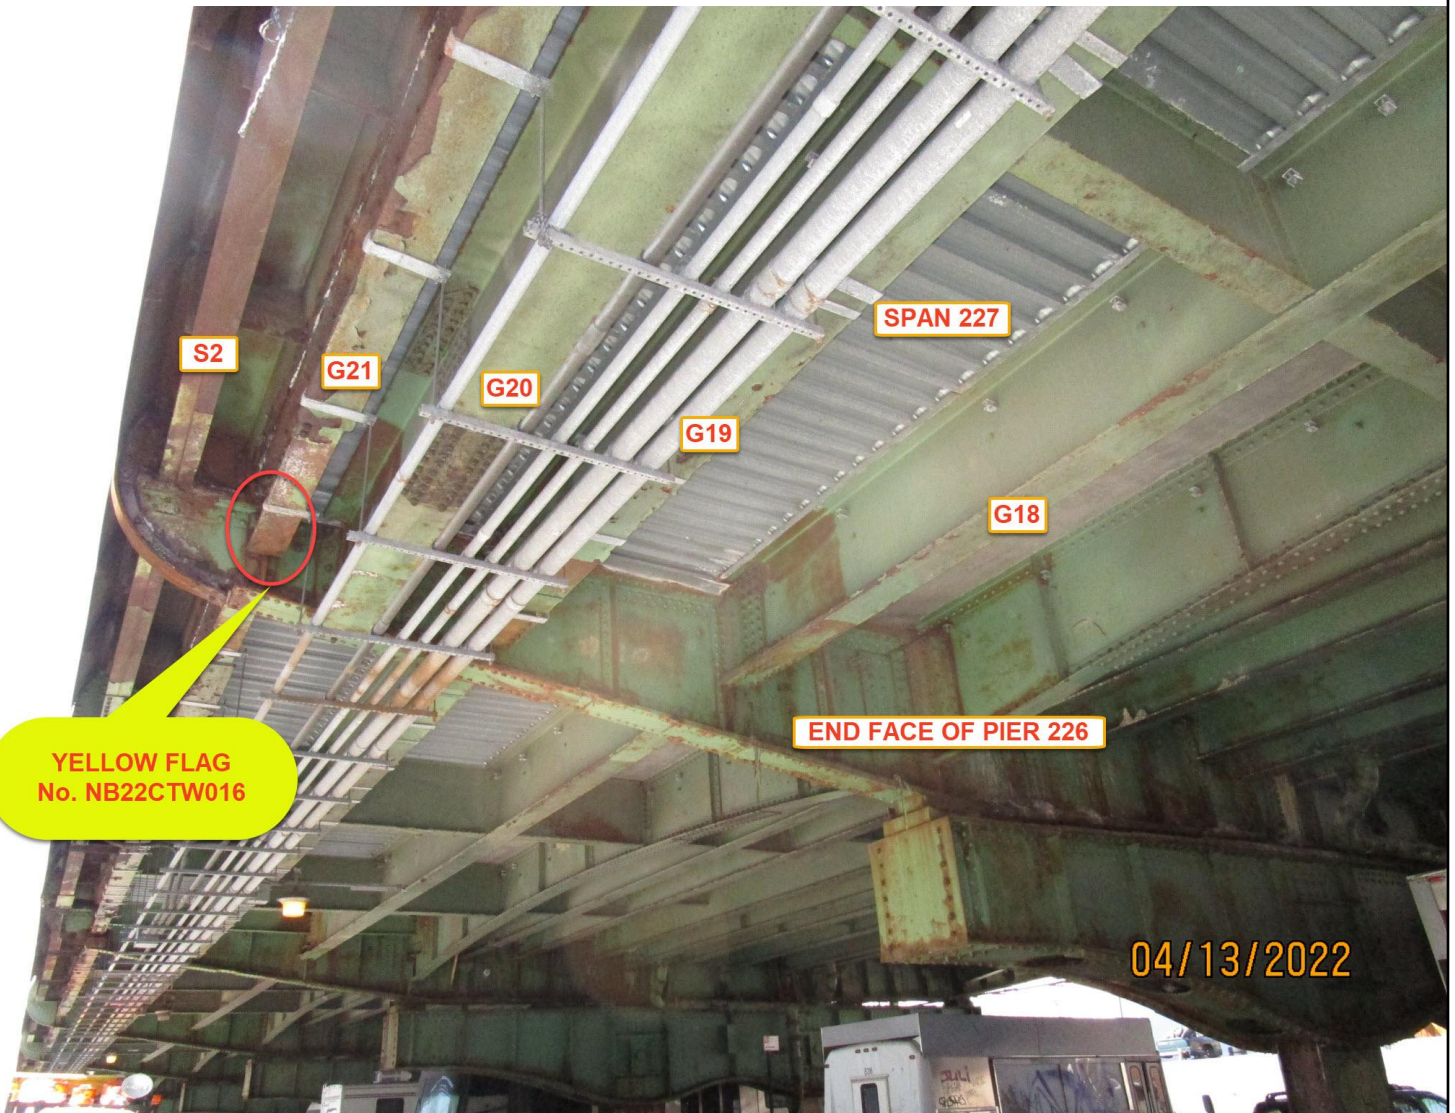
Photo Number: 1

Attachment Description: Span 227, Girder G21 at Pier 226 – General Framing at Flagged Location. Looking Begin.

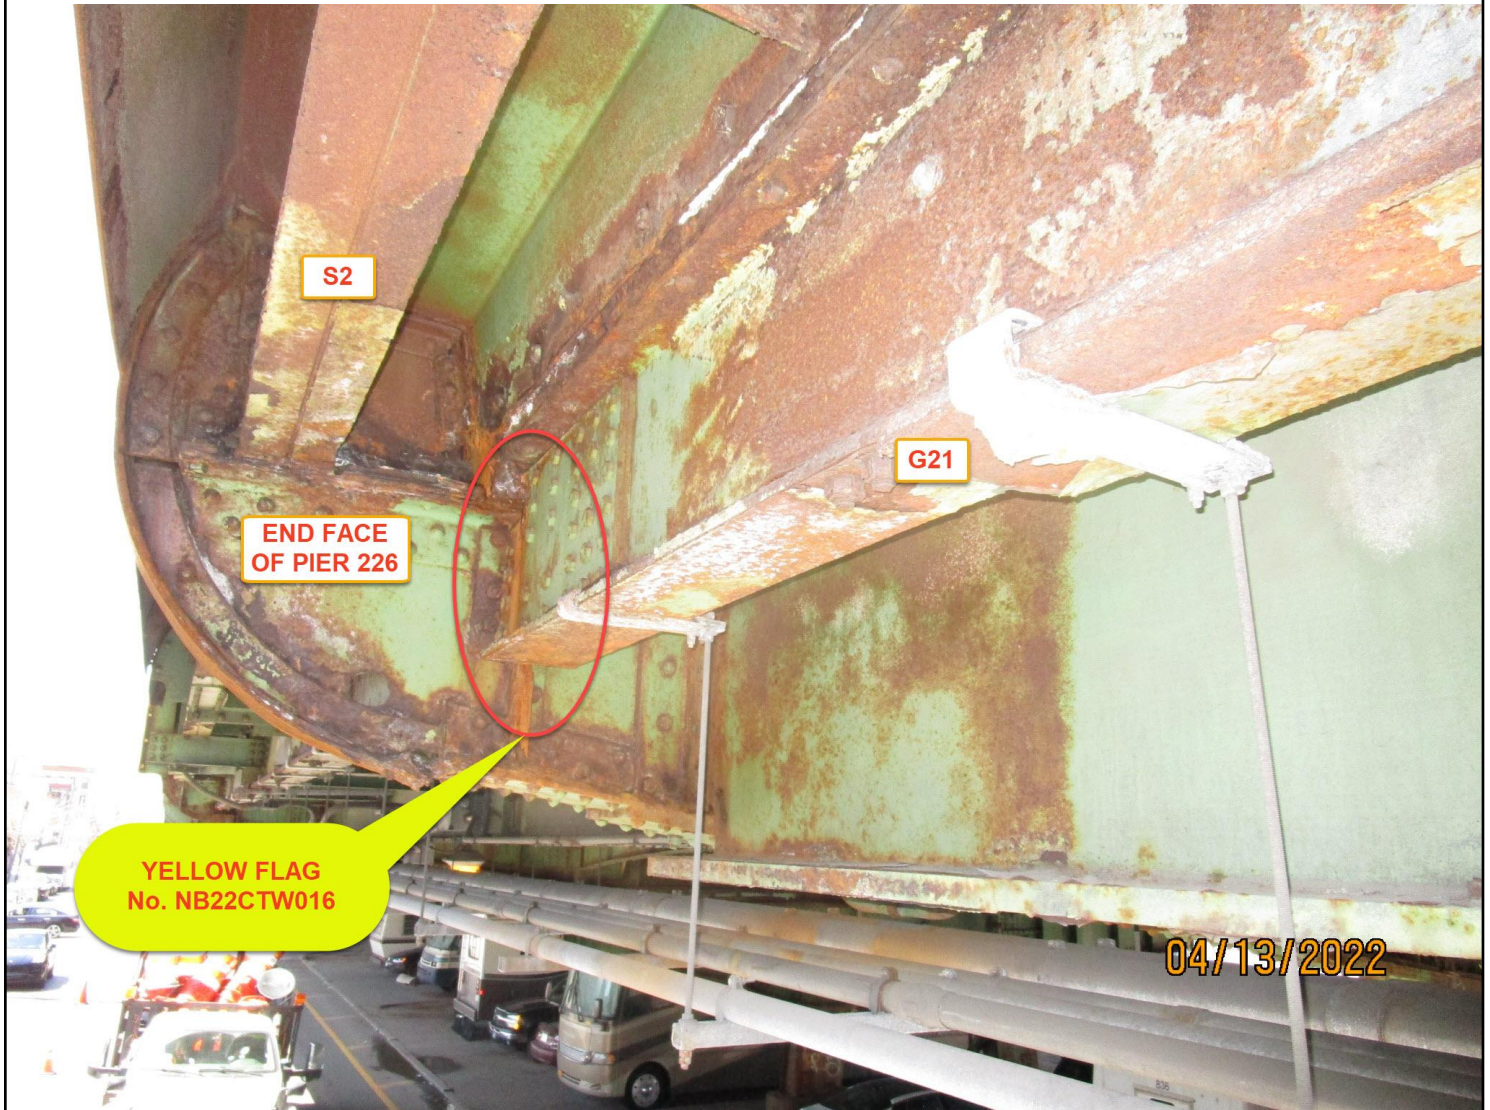
Photo Number: 2

Attachment Description: Span 227, Girder G21 at Pier 226 – General view of Flag Location. Looking Begin.

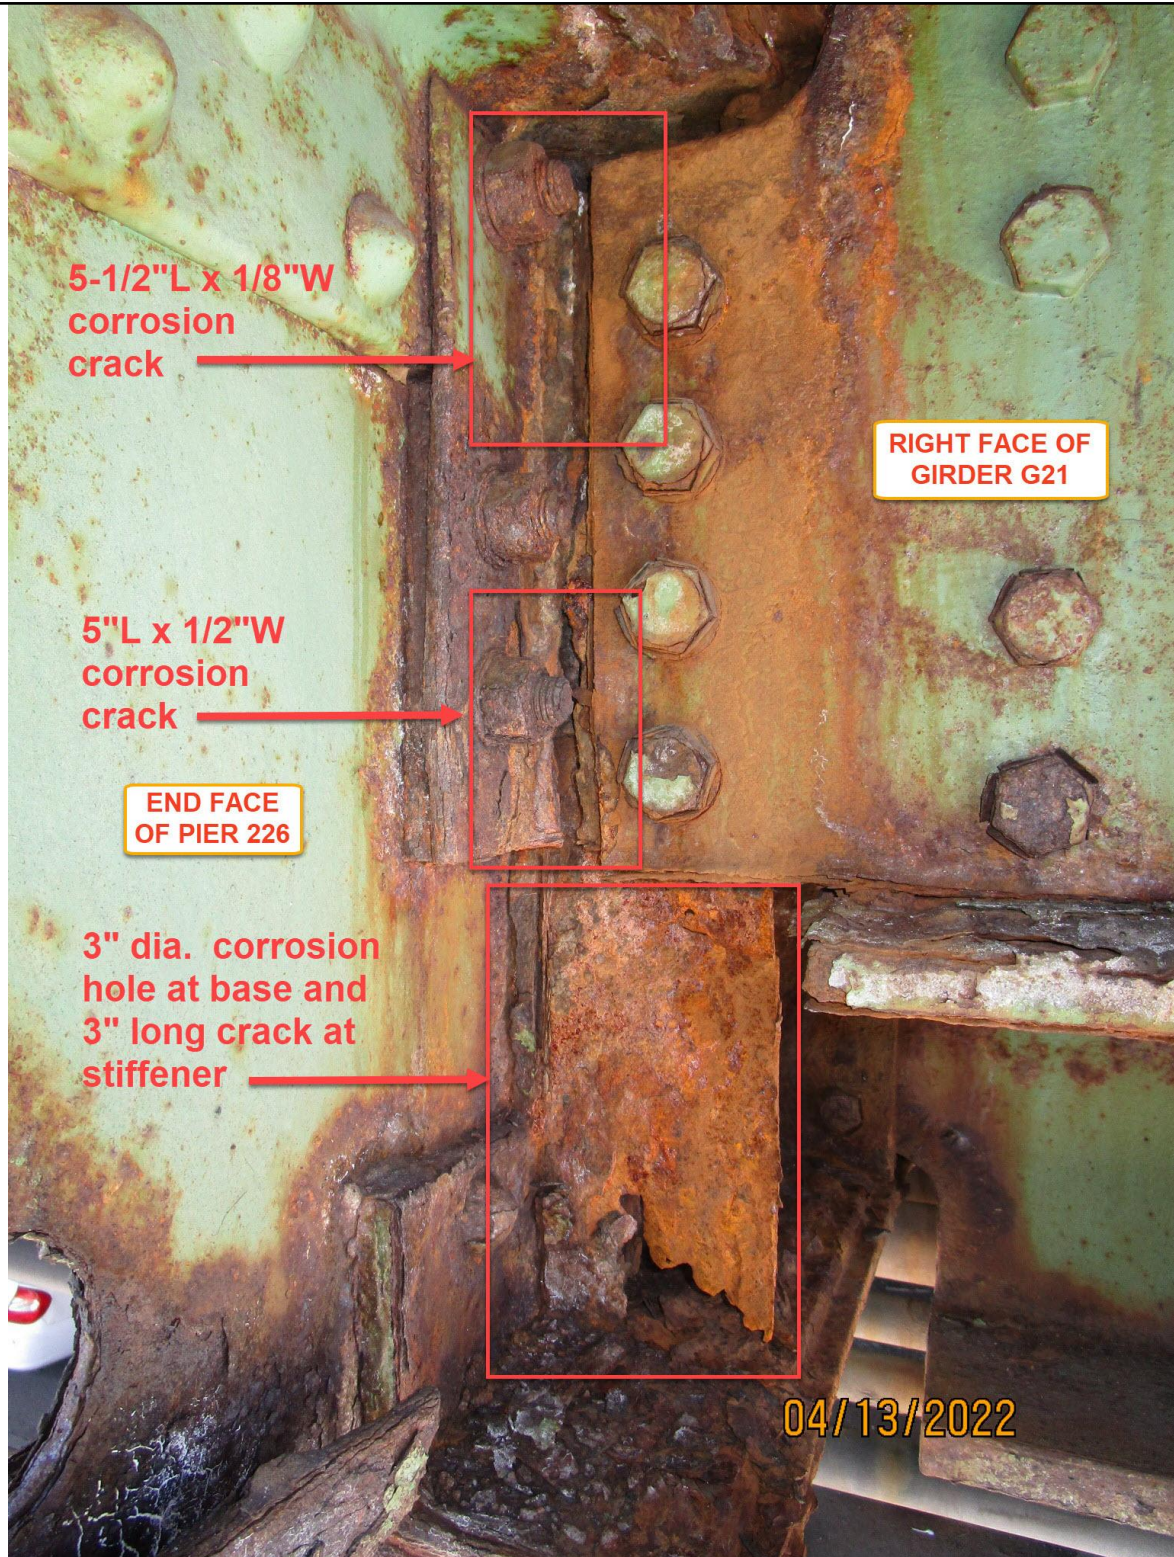
Photo Number: 3

Description: The right clip/connection angle of Girder G21 connection to the pier cap at Pier 226 exhibits a 5" long vertical corrosion crack x 1/2" wide (no change since previous inspection) at the lower fillet section. The upper fillet section has a 5-1/2" long vertical corrosion crack x 1/8" wide (no change since previous inspection). In addition, the vertical stiffener/connection angle is heavily corroded and has a 3" diameter hole at the base and a 3" long horizontal crack (previously 2-1/2" long) 9" above the bottom flange of the pier cap. The areas adjacent to the crack and corrosion hole have up to 75% section loss with two 1/8" dia. holes.

Attachment Description: Span 227, Girder G21 at Pier 226 – General close-up view of the flagged condition. Looking Left.

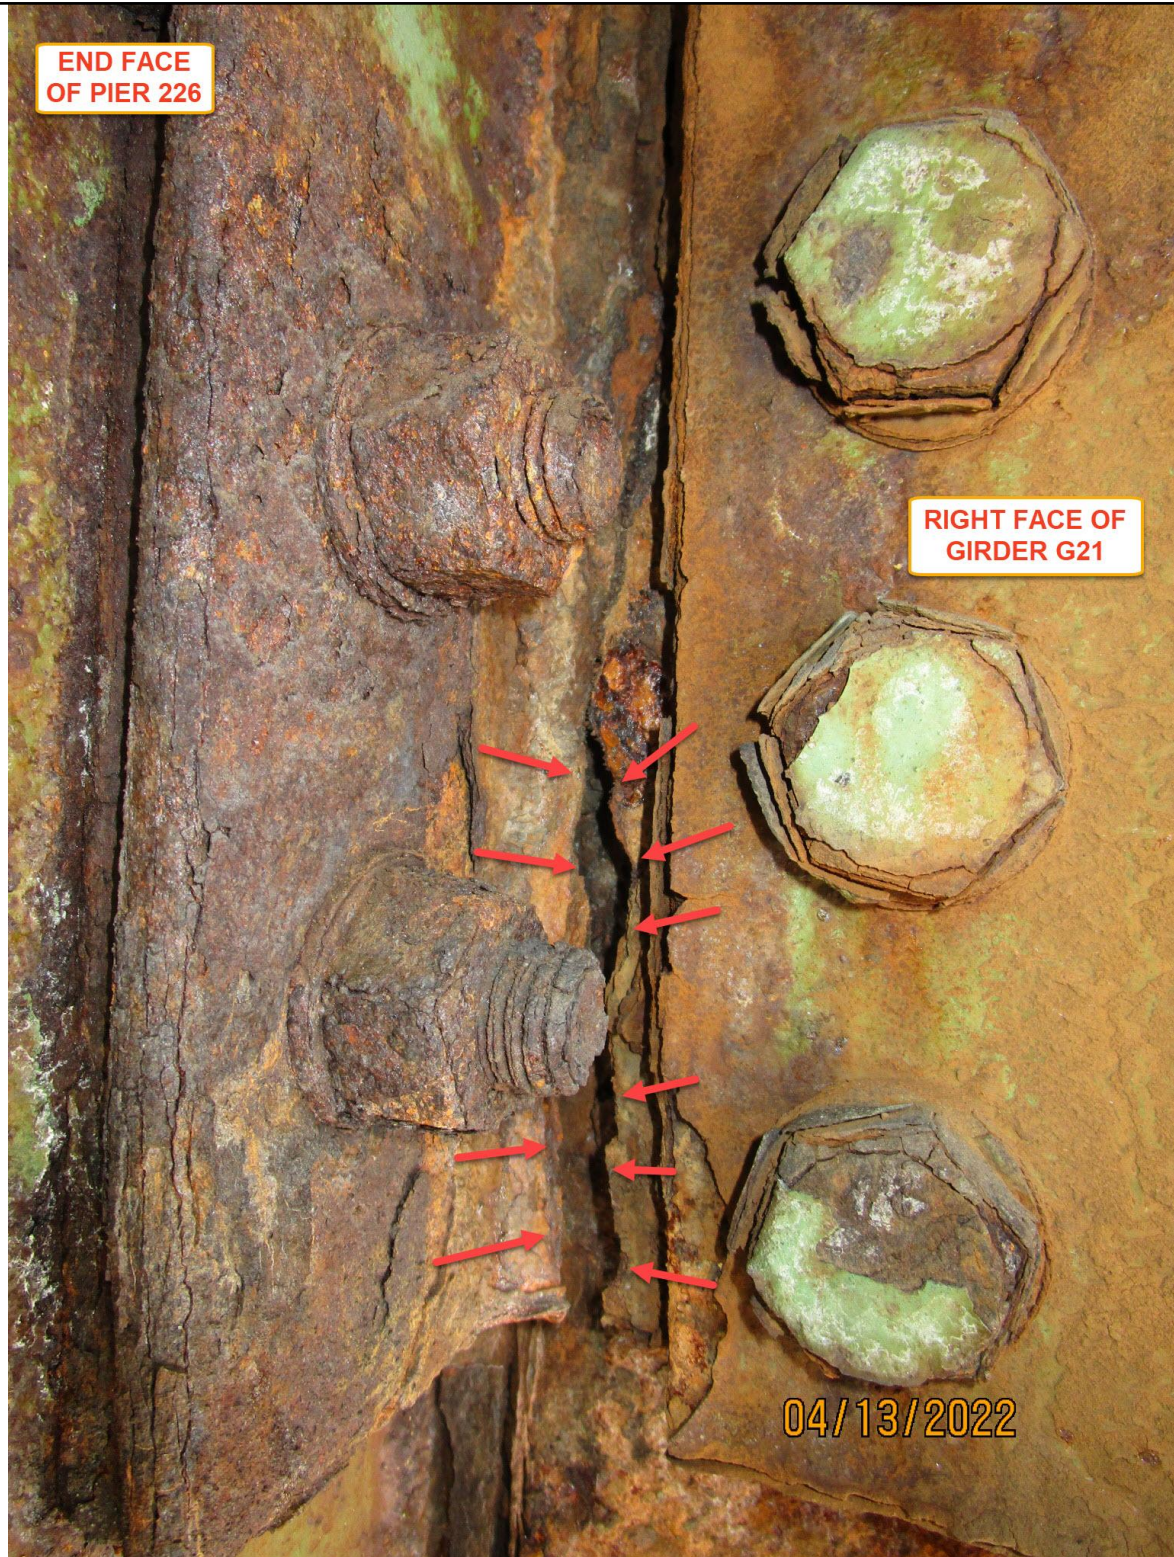
Photo Number: 4

Attachment Description: Span 227, Girder G21 at Pier 226 – Close up view of the lower section of connection angle. 5”L x 1/2”W corrosion crack. Looking Left.

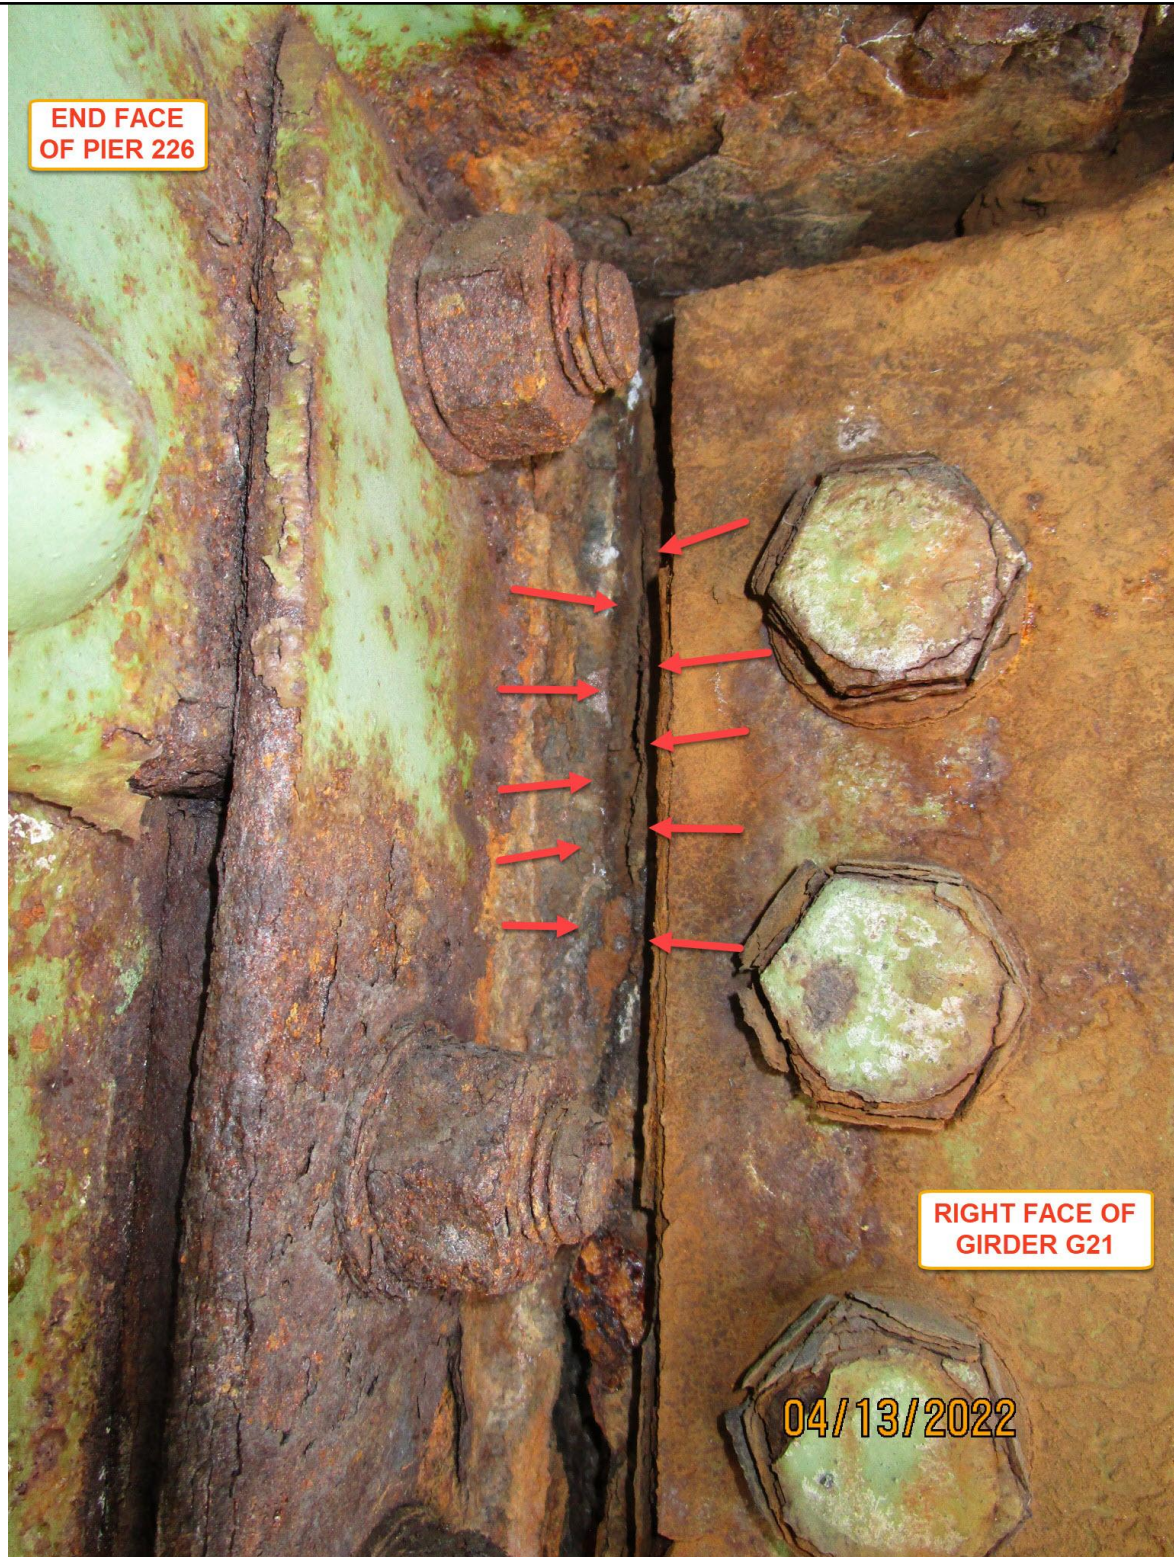
Photo Number: 5

Attachment Description: Span 227, Girder G21 at Pier 226 – Close-up view of the upper section of connection angle. 5'-1/2" L x 1/8" W corrosion crack. Looking Left.

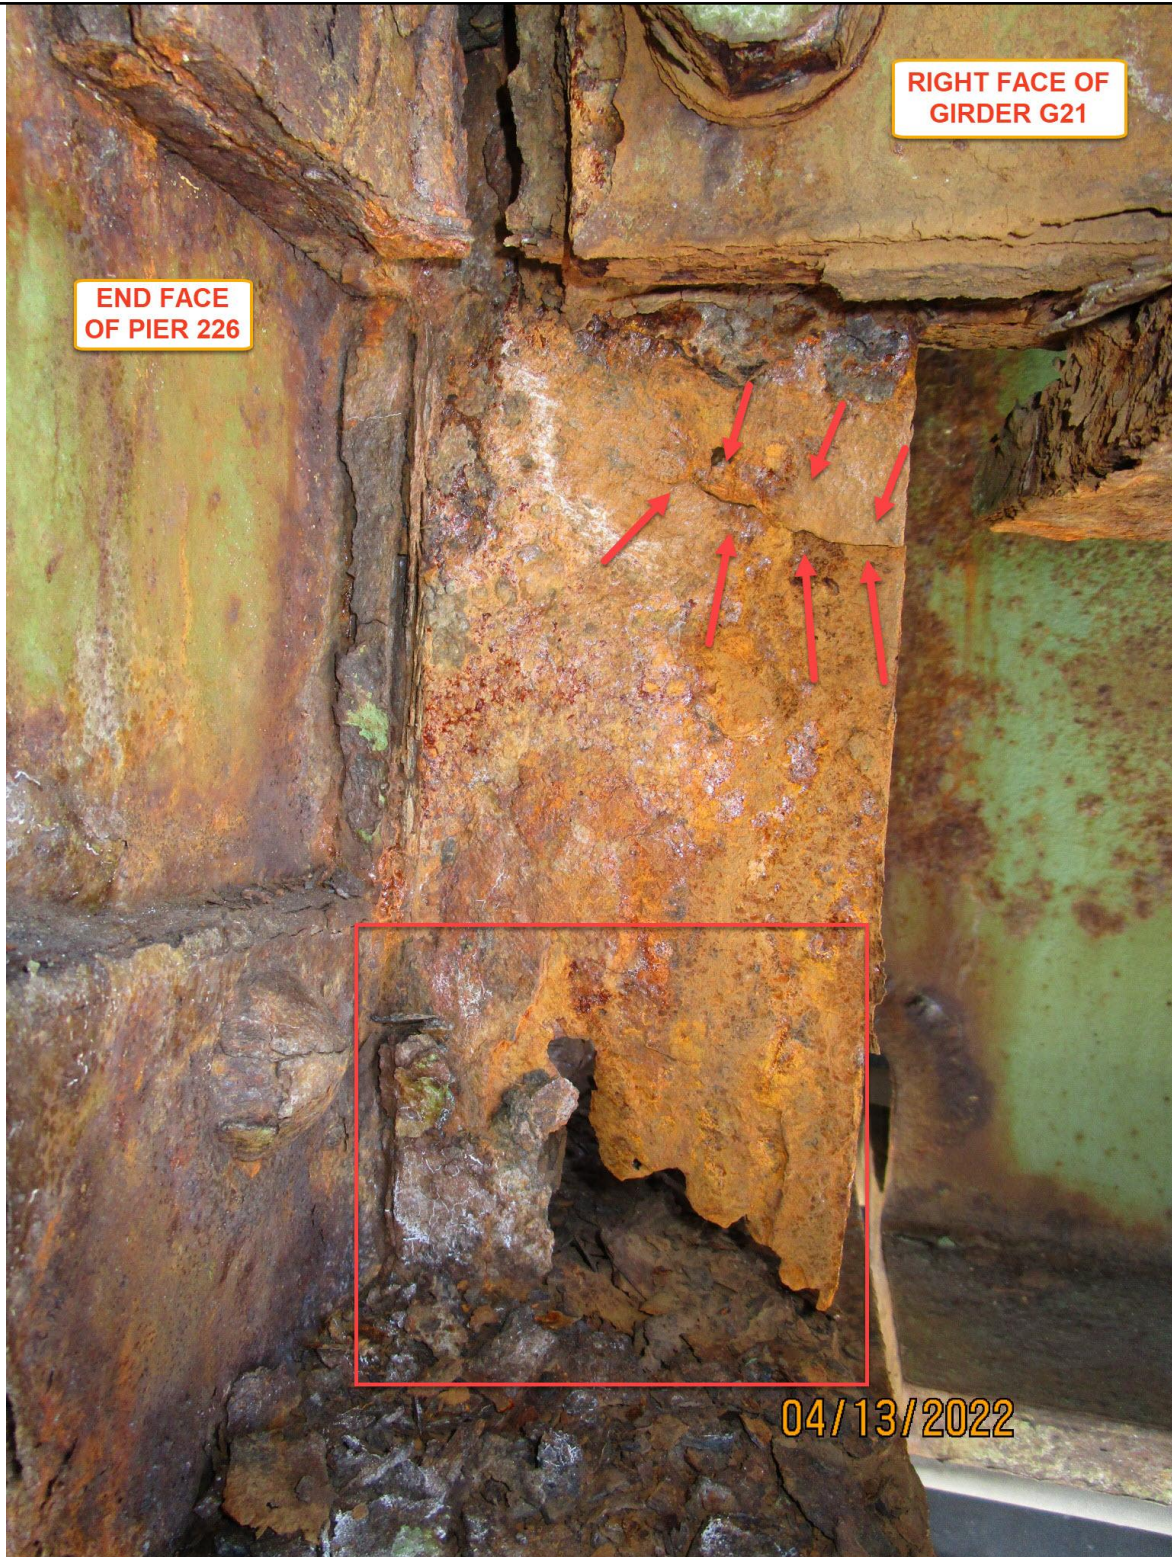
Photo Number: 6

Attachment Description: Span 227, Girder G21 at Pier 226 – Close-up view of the stiffener connection angle. 3" diameter corrosion hole at base and 3" long horizontal crack approx. 9" above bottom flange of pier cap. Looking Left.

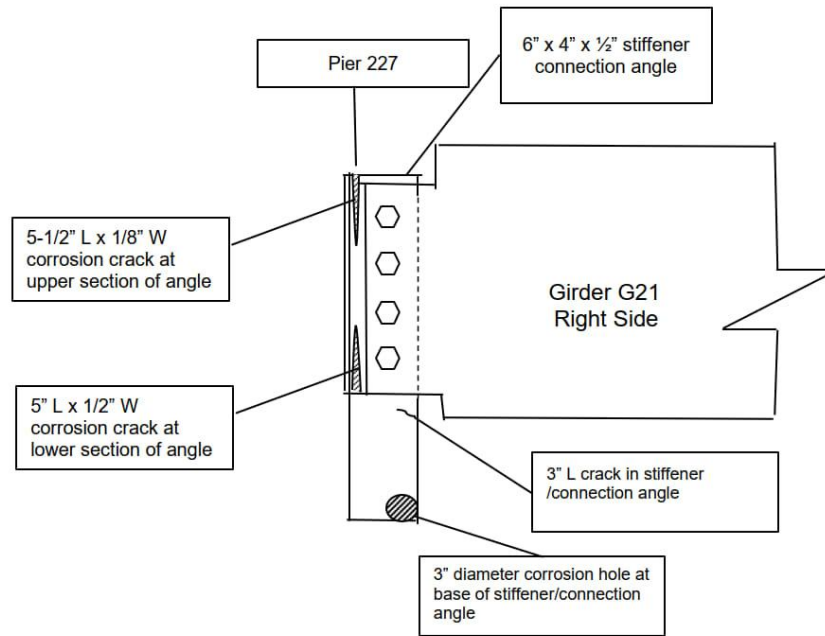
Photo Number: 7

Right side of Girder G21 at PIER 226 – Looking Left**Attachment Description: SN 227 G21 at Pier 226 Sketch**

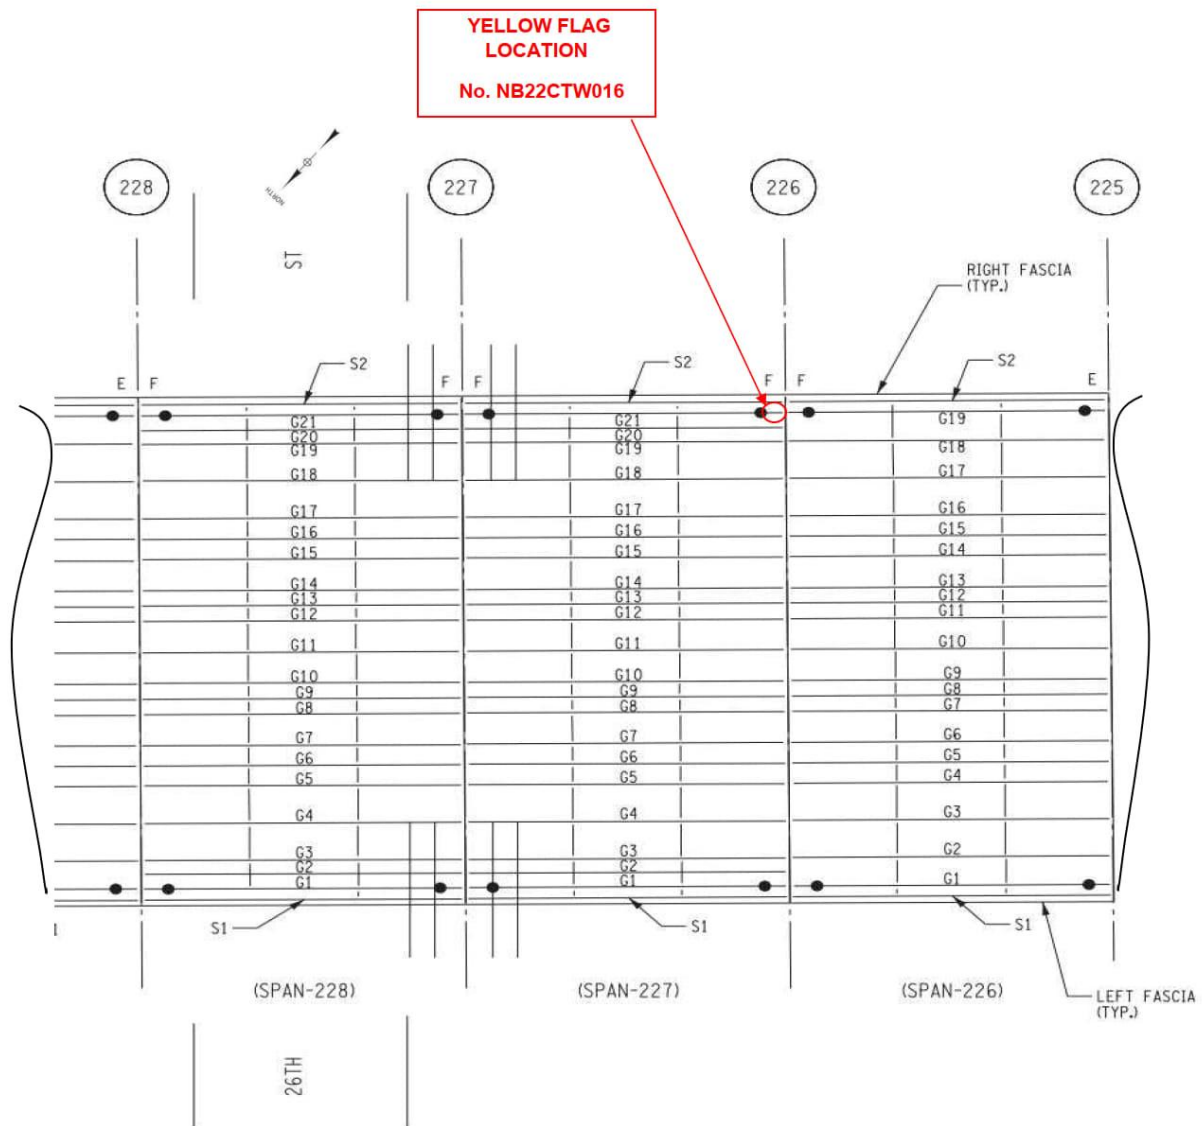
Photo Number: 8

Attachment Description: SN 227 G21 at Pier 226 Framing Plan
